Battery Wimberly
A Preliminary Topographical and Documentary Survey
Wormsloe State Historic Site
Savannah, Georgia

by
L. E. Babits
Armstrong State College
August 1992

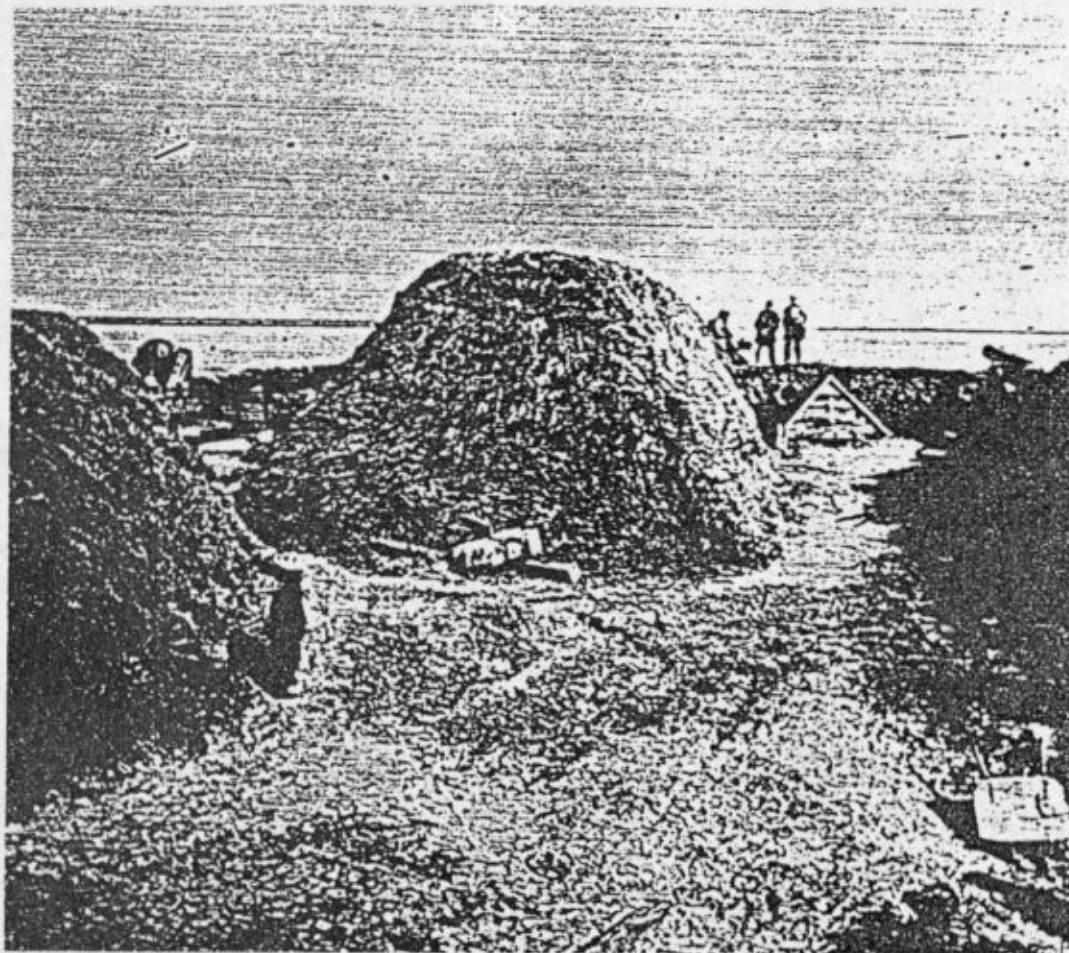
Traverse III (See figure 9)

This traverse is eight feet above the top of the parapet and extends to the rear 35 feet. It is twelve feet above the interior ground surface of the fort. Since a square rear portion of the mound would effectively block the entrance, the mound comes to a point as it slopes to the original ground surface inside the fort.

Figure 9
1864 Photograph of Traverse
Fort McAllister, Richmond Hill, Georgia

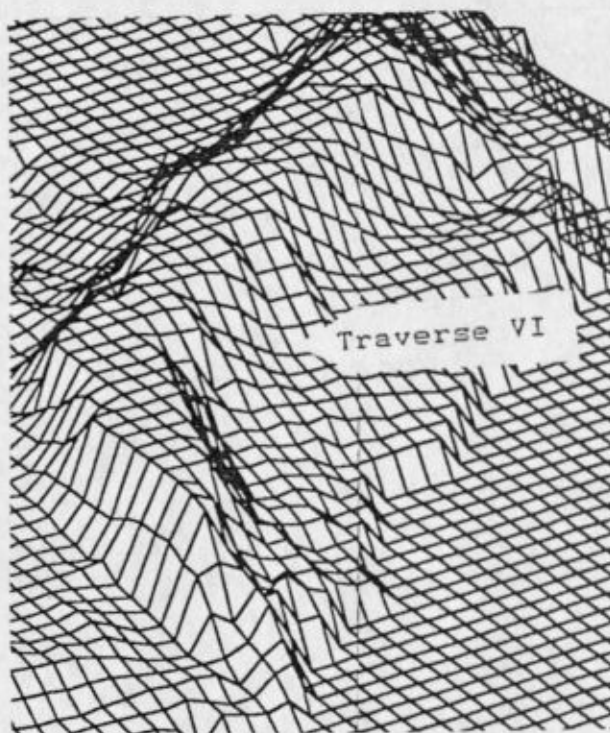
Traverse VI (Figure 13)

Figure 13A
30 Degrees Elevation/300 Degrees Orientation (View to South)

Figure 13B
Isometric of Traverse Number 6
30 Degrees Elevation/30 Degrees Orientation (View to North)

This is the most complex of the traverses. It is a very large mound, extending 10 feet above the original ground surface. It is not straight but rather curves from a northly heading to a northeastern heading with an angle of about 120 degrees. The top of this mound is flat and rectangular. It is in remarkably good condition.
